In-situ X-ray Observation of Molten Pool Depth during Laser Micro Welding

To clarify phenomena which cause strength decrease in the molten pool during laser welding processes, we have carried out X-ray imaging of inside materials using intense synchrotron radiation during laser welding. An air-cooled continuous wave fiber laser was used for welding. When the laser beam was irradiated on sample materials, molten pool shape were successfully observed using an X-ray absorption contrast technique. Moreover, bubbles in molten pool and cracks in weld metal were clearly observed. Butt welding for heat exchanger tubes was demonstrated by a specially designed probing system. The probing system consisted on a composite-type optical fiber, a laser processing head, air-cooled fiber laser and so on. Here, the surface of the weld bead was observed by fiber scope images. In such a repair welding, the observation of the inside material by X-ray imaging is very effective because it can inform us how the weld depth could grow and why the weld defect would be born.

Keywords: Intense X-ray beam, Laser welding, Molten pool, X-ray imaging, Bubbles, Cracks

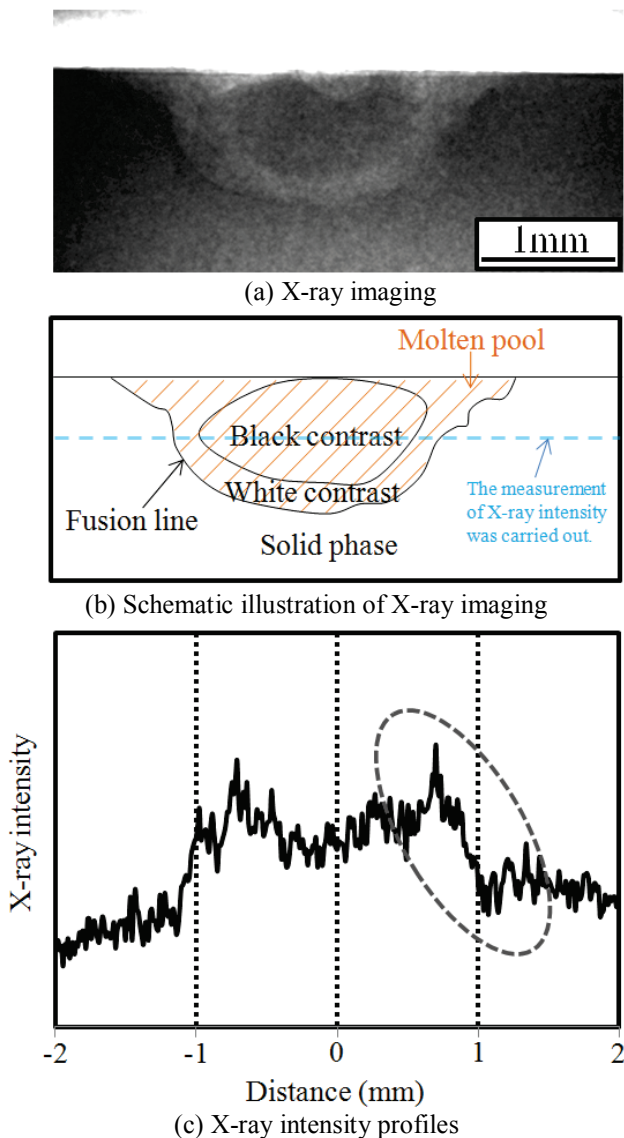
Figure 3 shows an image of a molten pool during spot welding and X-ray intensity profiles. The fiber laser power was 330 W. It is known that density of liquid phase of pure iron is 7015 kg/m³ at 1809 K and the density of solid phase is 7874 kg/m³ at room temperature [8]. Here, the 11 % difference in density made it possible to observe the fusion line by 70.3 keV synchrotrons X-ray. Moreover, the contrast difference can be confirmed in molten pool. The black

contrast was observed in center of molten pool and white contrast was observed in interfacial neighborhood. To investigate this contrast difference, X-ray intensity was measured at broken line as shown in Fig. 3 (b). The X-ray intensity was increased inside of the fusion line and was decreased outside of the fusion line, as shown Fig. 3 (c) (circle). This edge enhancement was a feature of refraction contrast. In absorption contrast, the contrast results from variation in X-ray absorption arising from density differences and from variation in the thickness and composition of the sample materials. In refraction contrast, shape of sample materials and boundary of the internal structure are enhanced. Therefore, the fusion line was enhanced by refraction contrast.

Figure 3 Observed images of molten pool by X-ray contrast

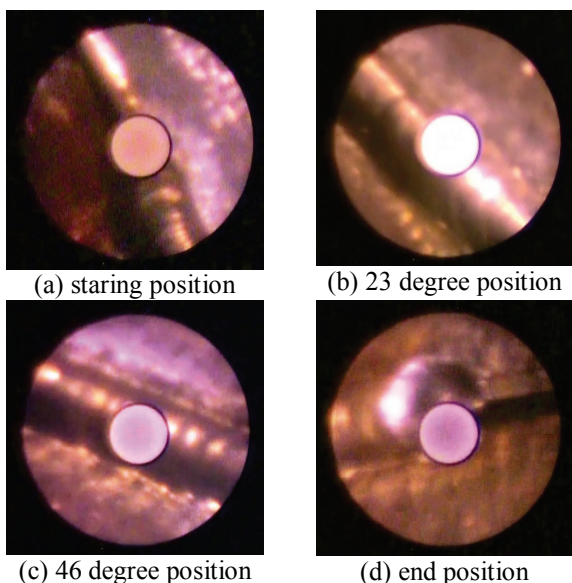
Figure 10 shows the example of the butt welding experimental results. The laser spot scanning speed was 1.4 mm/s and laser output power was 330 W. These images were taken by the composite-type optical fiber scope just after the butt welding. Figure 10 (a) shows the position of starting position of the laser welding. A circle at the center of the photograph is a part of the fiber that transmits high energy laser beam. The part from the center to the left diagonal direction shows the contacted interface of the short tubes without laser irradiation. As for the right diagonal direction, the welding bead was clearly formed. The length of the welding bead was 14 mm and the scanning time was 10 seconds that corresponded with 70 degree. During observation, these inner wall images rotated in keeping with scanning. Here the welding bead has constant width of 1.5 mm and smooth welding surface shown in both Fig. 10 (b) and Fig.10 (c). At the end of the welding bead, a molten pool of 2 mm diameter was formed in Fig. 10 (d). Inside

(a) starting position (b) 23 degree position
(c) 46 degree position (d) end position
Figure 10 the example of the butt welding
These views are taken from the inside of 1-inch tube
by a composite-type optical fiber scope.

materials are predictable from the result of X-ray imaging. For example, comparing the in-situ X-ray absorption and the microscopic observation, the molten pool depth of around more than 0.3 mm could be expected. Moreover, it is expected that short laser irradiation time could reduce the porosity of the molten pool.
