Thermal Damage of Carbon Fiber Reinforced Plastic by IR Fiber Laser Irradiation

Hiroyuki Niino^{*1}, Yoshihisa Harada^{*1}, and Akira Fujisaki^{*2}

DOI: 10.2961/jlmn.2017.03.0011

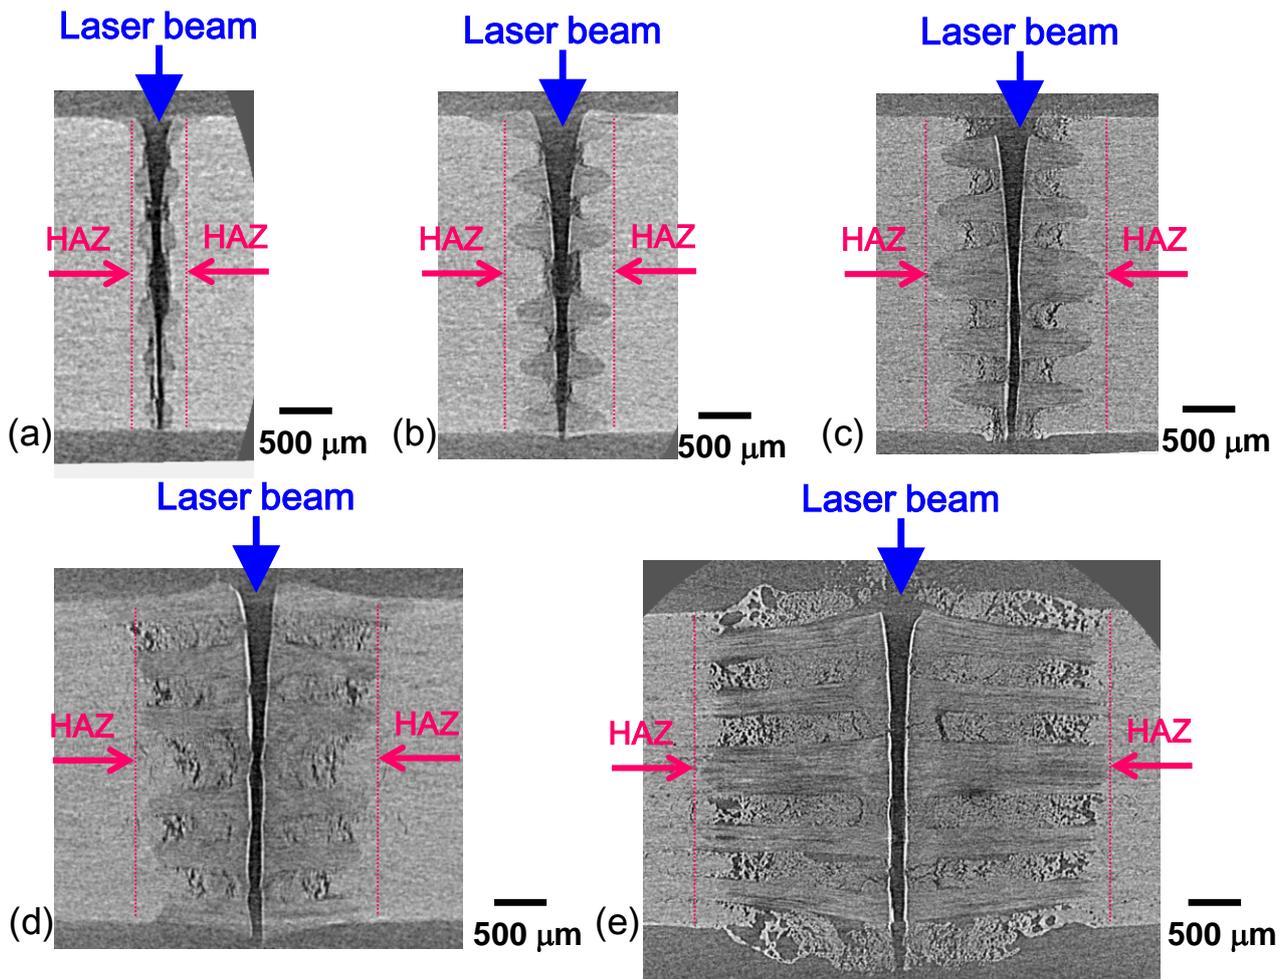
Fig. 1 Side-view cross-sectional X-CT images of 3-mm-thick CFRP plates cut by CW 3.3-kW fiber laser irradiation using the multi-pass method. The laser scanning speed was (a) 3.6 m s^{-1} , (b) 0.5 m s^{-1} , (c) 0.2 m s^{-1} , (d) 0.1 m s^{-1} , and (e) 0.05 m s^{-1} . Thermally damaged areas are labeled “HAZ” (heat-affected zone). The laser scanning speed of 3.6 m s^{-1} was maximum for the laser irradiation system.

Figure 1 shows cross-sectional X-CT images of the trench structure on a CFRP sample obtained after CW fiber laser cutting with an average power of 3.3 kW using the multi-pass method. The number of passes to completely cut the 3-mm-thick CFRP plates are listed in Table 1 for each scanning speed. The laser irradiation formed a deep trench structure with a high aspect ratio. The kerf at the trench surface was 300 μm wide, and the internal trench width was about 200 μm wide. The kerf of the trenches was tapered in Fig. 1. This tapered structure would be attributed to the intensity attenuation of the incident laser beam into 3-mm thick-sample.

The dark areas in Fig. 1 are attributed to epoxy resin degradation and evaporation during the laser irradiation. The gray area of the samples in Fig.1 was resin region. Thermogravimetric analysis has shown that the epoxy resin of CFRP thermally decomposes above 300°C [12], suggesting that the damaged area was transiently above 300°C during the laser irradiation.

As the CFRP sample consists of 12 cross-ply laminates with 0/90° orientations, the damaged area expanded inhomogeneously from the sidewall surface into the CFRP bulk. At the fiber layer perpendicular to the laser-cutting direction at scanning speeds of 3.6 – 0.2 m s^{-1} , a large damaged area was observed because the carbon fiber provided the dominant heat conduction path. The top-view cross-sectional images in Fig. 2 clearly show epoxy resin degradation without carbon fiber damage.

As shown in Fig. 1, the trench sidewall damage strongly depended on the laser scanning speed, which was varied between 3.6 and 0.05 m s^{-1} . Table 2 indicates the maximum thickness of the thermally damaged area produced by laser irradiation in the CFRP plates at these laser scanning speeds. The minimum thermal damage was obtained using a scanning speed of 3.6 m s^{-1} .

Although the damage area in the trench at the laser irradiation of the slow scanning speed (Figs. 1 (d) and (e)) was about the same parallel and perpendicular, the area at the fast scanning (Fig. 1(a) and (b)) was much larger parallel than at slow scanning. This would be attributed to a slow heat conduction of resin region ($D = 0.023 \text{ cm}^2 \text{ s}^{-1}$) [13].

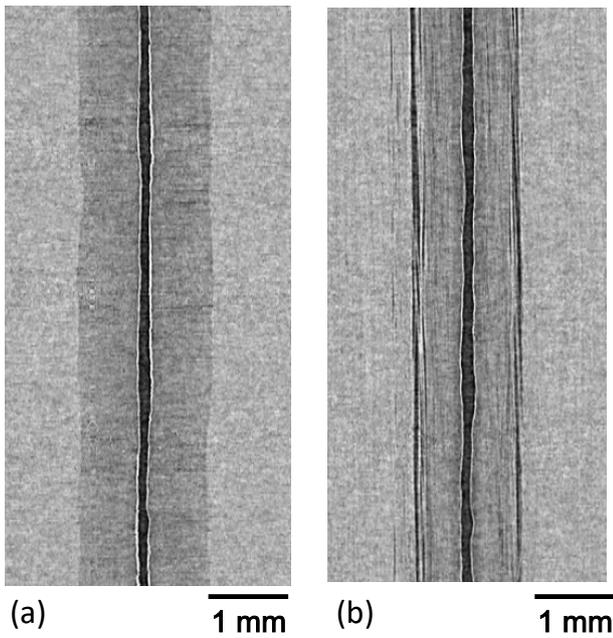
Fig. 2 Top-view cross-sectional X-CT images of the 3-mm-thick CFRP plate cut by CW 3.3-kW fiber laser irradiation using the multi-pass method (3 passes). The laser scanning speed was 0.1 m s^{-1} . The section depths are (a) fifth layer from the surface and (b) sixth layer from the surface.

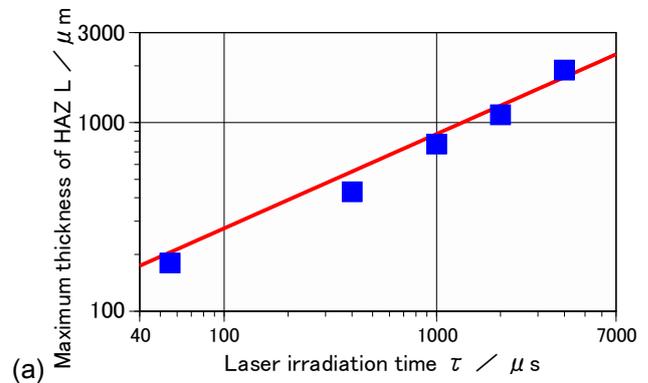
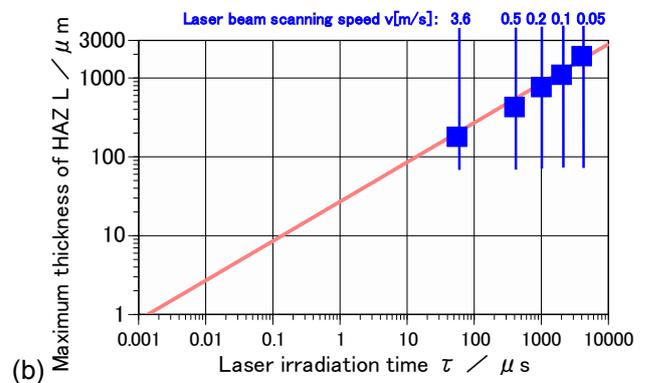
Fig. 3 Maximum thickness L of thermally damaged region plotted as function of laser irradiation time τ . Plots are for (a) microsecond region and (b) nanosecond to microsecond region. Red line in both plots are fits using Eq. (2).

where φ is the laser beam diameter (corresponding to the internal trench width of $200 \mu\text{m}$) and v is the laser scanning speed. In this experiment, the laser irradiation time τ was varied widely, from $56 \mu\text{s}$ to 4 ms . The maximum thickness of the thermally damaged area L in a CFRP plate is plotted as function of laser irradiation time τ in Fig. 3. A linear relation between L and the square root of τ was obtained. The heat penetration depth was defined from the parameters L and τ and the thermal diffusivity constant D [5]:

On the basis of curve fitting using equation (2) for the data in Fig. 3, D was estimated to be about $1.98 \text{ cm}^2 \text{ s}^{-1}$. Red line in both plots in Fig. 3 are fits using equation (2). This value was almost in agreement with the experimentally measured value for in-plane, uni-directional thermal diffusivity ($D = 2.18 \text{ cm}^2 \text{ s}^{-1}$) for a CFRP plate [13], suggesting that the damaged area propagated into the bulk CFRP through carbon fibers by a heat conduction during photo-induced thermal process.

When Fig. 3(a) was extended to the nanosecond regime, L was reduced to about 10 μm for an irradiation time of 100 ns [Fig. 3(b)]. If a scanning system 500 times faster with a high-peak-laser-power or a kW-class nanosecond pulsed laser was employed, the laser-cut trench would exhibit a clean top and excellent sidewall quality, and the thermally damaged region would extend only tens of micrometers from the trench.
